FIRE TEST REPORT: SOUTH SHORE IRON WORKS INTEGRITY WALL

PRODUCT: South Shore Iron Works Integrity Wall

STANDARD TESTED TO: ASTM E 119-08a
Standard Test Method for Fire Tests of Building
Construction and Materials

REPORT NO.: GL 62009

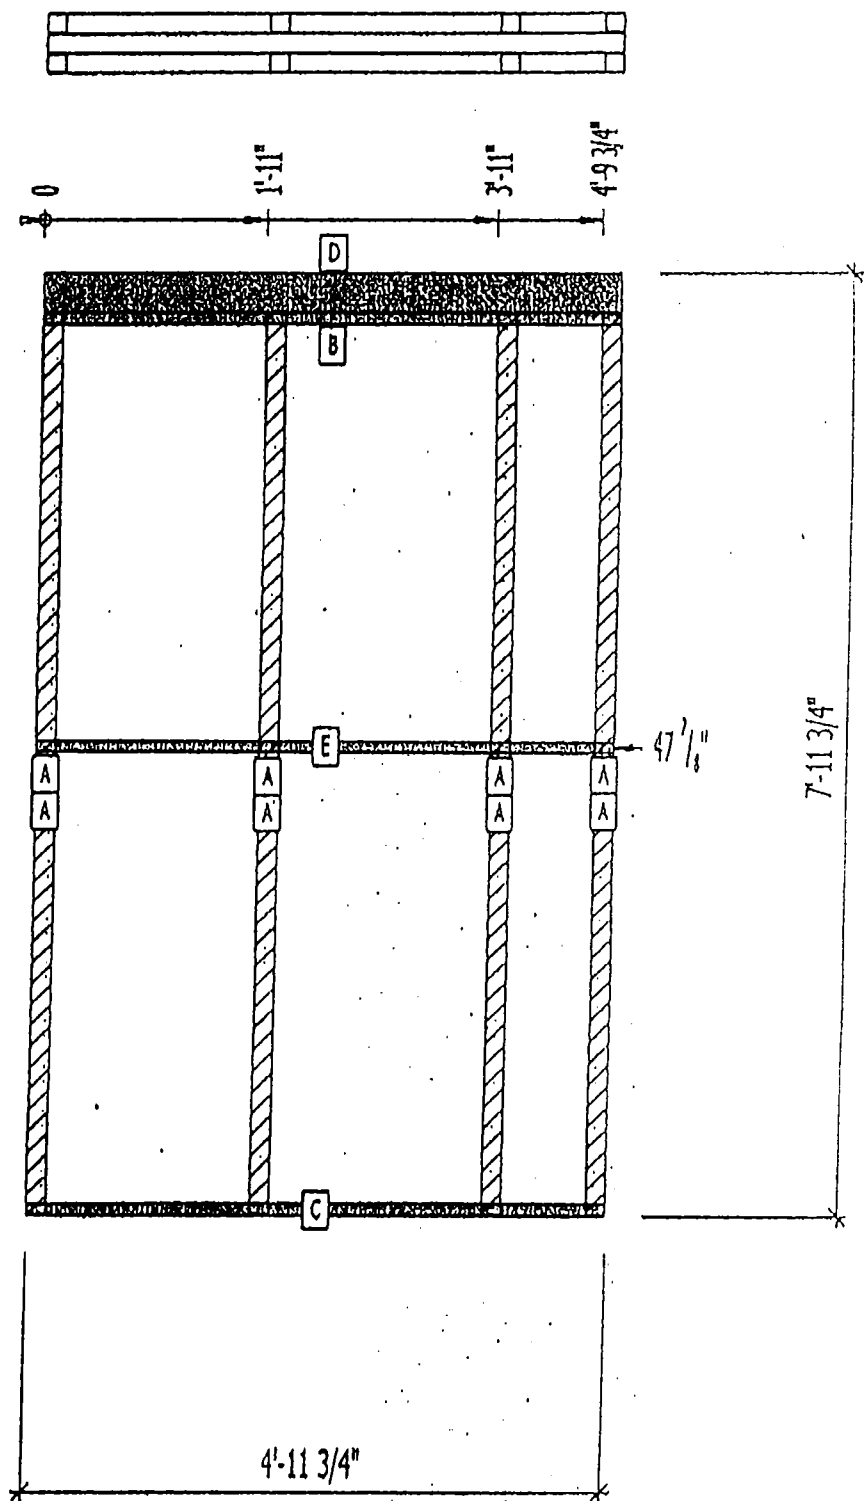
Drawing of Wall Construction

LABEL	QTY	SIZE	LENGTH	USE
A	8	2x2x16GA	7'-7 1/2"	STUD
B	1	600T125-54	4'-11 3/4"	TOP TRACK
C	1	600T125-54	4'-11 3/4"	BOTTOM TRACK
D	1	6x4x.1875	4'-11 3/4"	TOP STUD
E	1	2x1x16GA	4'-11 5/8"	HORIZONTAL BRACING

A drawing of the wall construction is attached.

The following is a detailed account of the construction of the South Shore Iron Works Integrity Wall. See attached drawings.

- 4.1.1 The wall tubular studs, tubular header and track, an all-welded system, is 6" wide. It consists of a 6" wide by 4" high by 3/16" thick steel tube header. The bottom track is 6" wide, 16 gauge steel with 1" legs. The studs are 2" x 2" by 1/8" steel tubes spaced 2" apart with a 2" tube horizontal stabilizer in the center at mid height.
- 4.1.2 Mineral wool batts, 8 pounds per cubic foot weight, 2 inches thick, 2 feet wide by 4 feet long were installed into the steel studs via friction fit.
- 4.1.3 5/8" type SCX gypsum wallboard was installed vertically. Each side had vertical joints.
