FIRE TEST REPORT: SOUTH SHORE IRON WORKS "INTEGRITY" WALL

PRODUCT: South Shore Iron Works "Integrity Wall"

STANDARD TESTED TO: ASTM E 119-10b
Standard Test Method for Fire Tests of Building
Construction and Materials

REPORT NO.: GL 94211

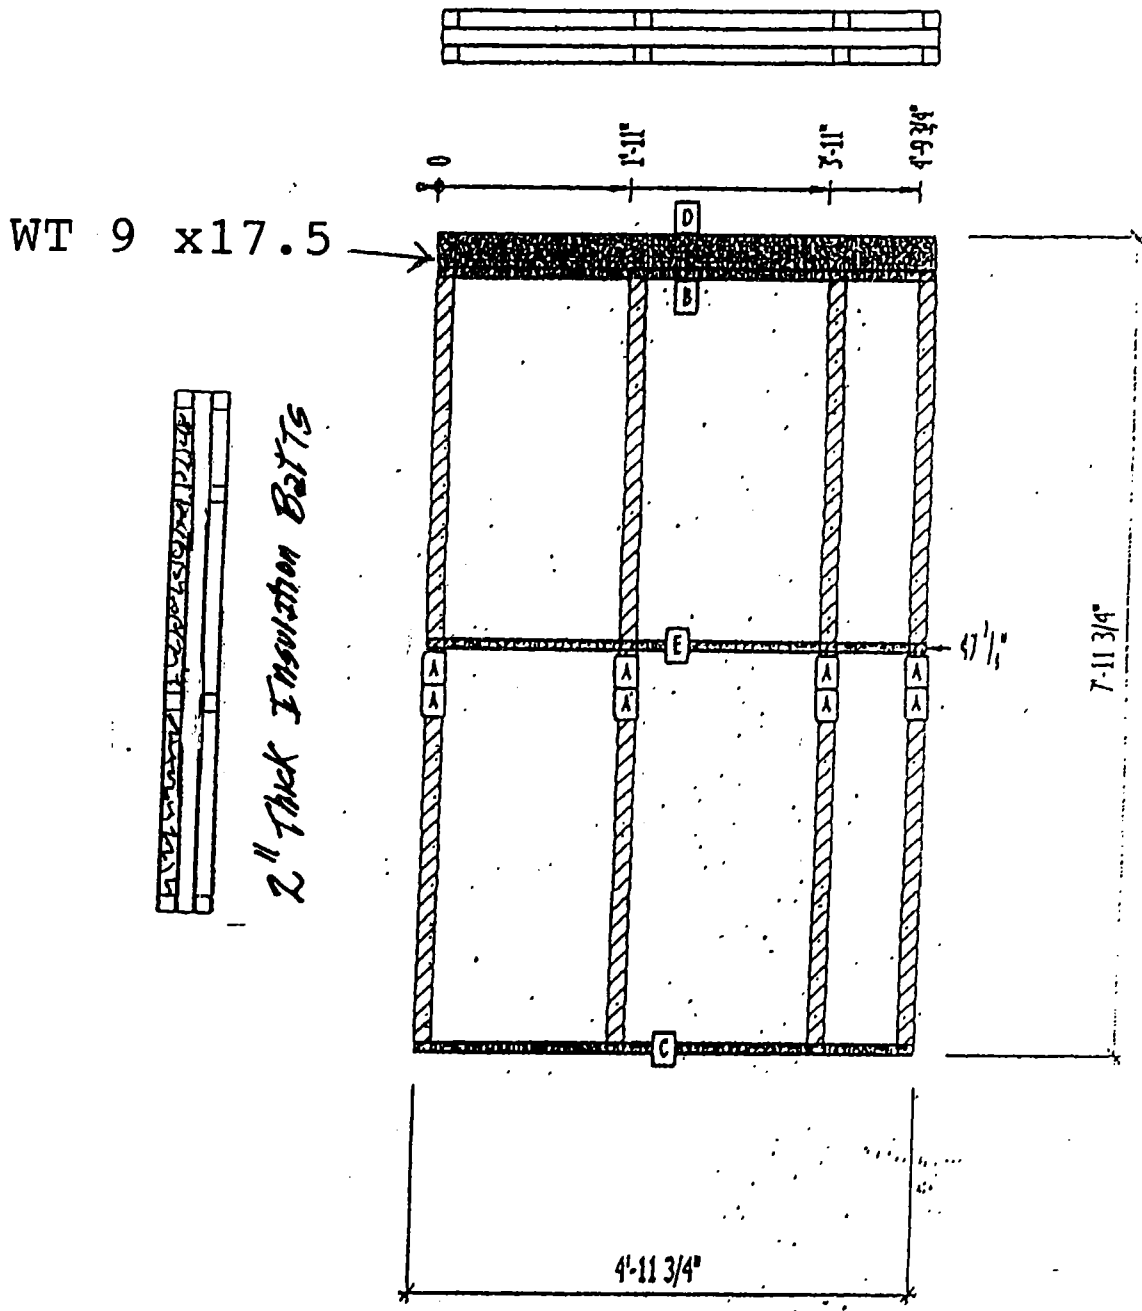
DRAWING OF WALL CONSTRUCTION

- 4.1.1 The wall tubular studs, T beam header and track, an all-welded system, is 6" wide. It consists of a "T" steel section 6" wide x 8" high. The bottom track is 6" wide, 16 gauge steel with 1" legs. The studs are 2" x 2" 16 gauge steel tubes spaced 2" apart with a 2" tube horizontal stabilizer in the center at mid height.
- 4.1.2 Mineral wool batts, 8 pounds per cubic foot weight, 2 inches thick, 2 feet wide by 4 feet long were installed into the steel studs via friction fit.
- 4.1.3 5/8 inch type SCX gypsum wallboard, 1st layer, was installed horizontally. The face layer was installed vertically.

The wallboard 1st layer was fastened to the tubular steel with 1-1/4 inch long self-drilling, self tapping screws, 24 inches on center. The 2nd layer was fastened with 1-7/8" screws, 8 " on center.

4.1.4 2 inch wide fiberglass joint tape, self sticking, was applied to the wallboard joints on the unexposed side which is the inner side.

4.1.5 One coat of setting type wallboard joint compound, Dura Bond 90, was applied to the joints but not to the screw heads on the unexposed side.

4.1.6 Mineral wool batts, 8 pounds per cubic feet weight, 2 inches thick, 22" wide by 4 feet long were installed in the wall..

A drawing of the wall construction is attached.

The following is a detailed account of the construction of the South Shore Iron Works Integrity Wall. See attached drawings.

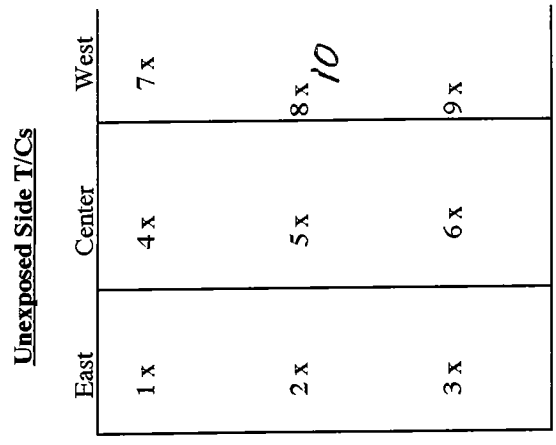
*T/C # 9 had detached from wall assembly between 15 and 55 minutes---reattached at 55 minutes---avg. did not include that

** T/C # 10 replaced T/C # 8 at #8 location at 80 minutes. T/C #8 stopped reading between 15 and 70 minutes.

Test Observations: There were no changes to the unexposed side during the entire test time.

9 thermocouples were placed on the unexposed face of the wall. Three T/Cs were placed at the top, center and bottom of the east, center and west sections of the unexposed surface of the test specimen. Refer to chart on page 9 of this report.

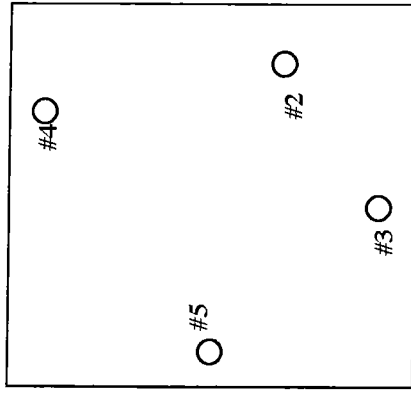
Furnace T/Cs

Thermocouples were equally spaced in the furnace. The temperatures are shown on the attached chart.

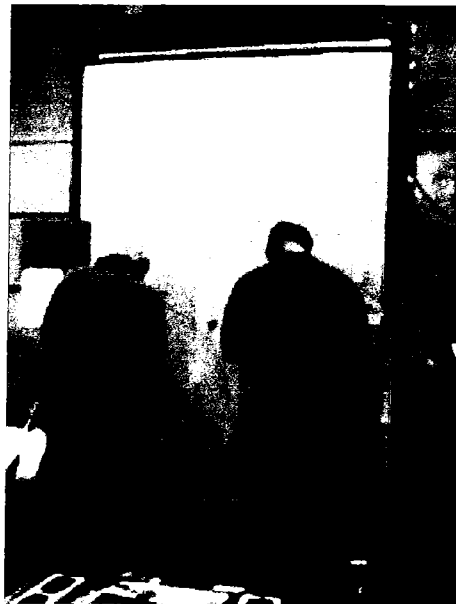
installing T/Cs on unexposed face
